Subject: UPDES Reconnaissance/Storm Water Inspection Cardiff Fork Site, Big Cottonwood Canyon

**JOINT UPDES RECONNAISSANCE/STORM WATER INSPECTION  
BUXTON COMPANY  
CARDIFF FORK SITE, BIG COTTONWOOD CANYON  
UMPERMITTED SITE  
AUGUST 8, 2011**

The site is a construction site located approximately 8 miles up Big Cottonwood Canyon near Cardiff Fork. The purpose of the project is to install a box culvert over Big Cottonwood Creek, and repair and replace the seal over several abandoned mines. The area of disturbance was estimated to be 0.6 acres. The site does not have a permit.

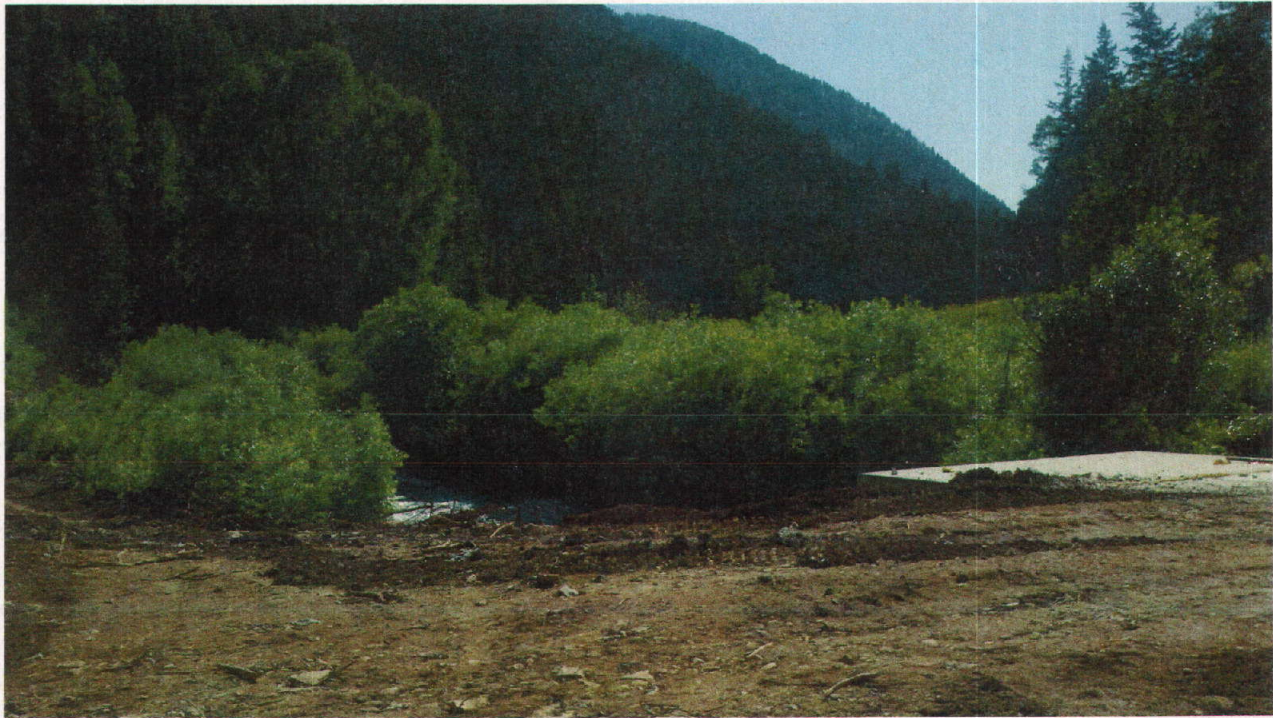
Photo 1. View of box culvert over Big Cottonwood Creek with grading work in foreground.

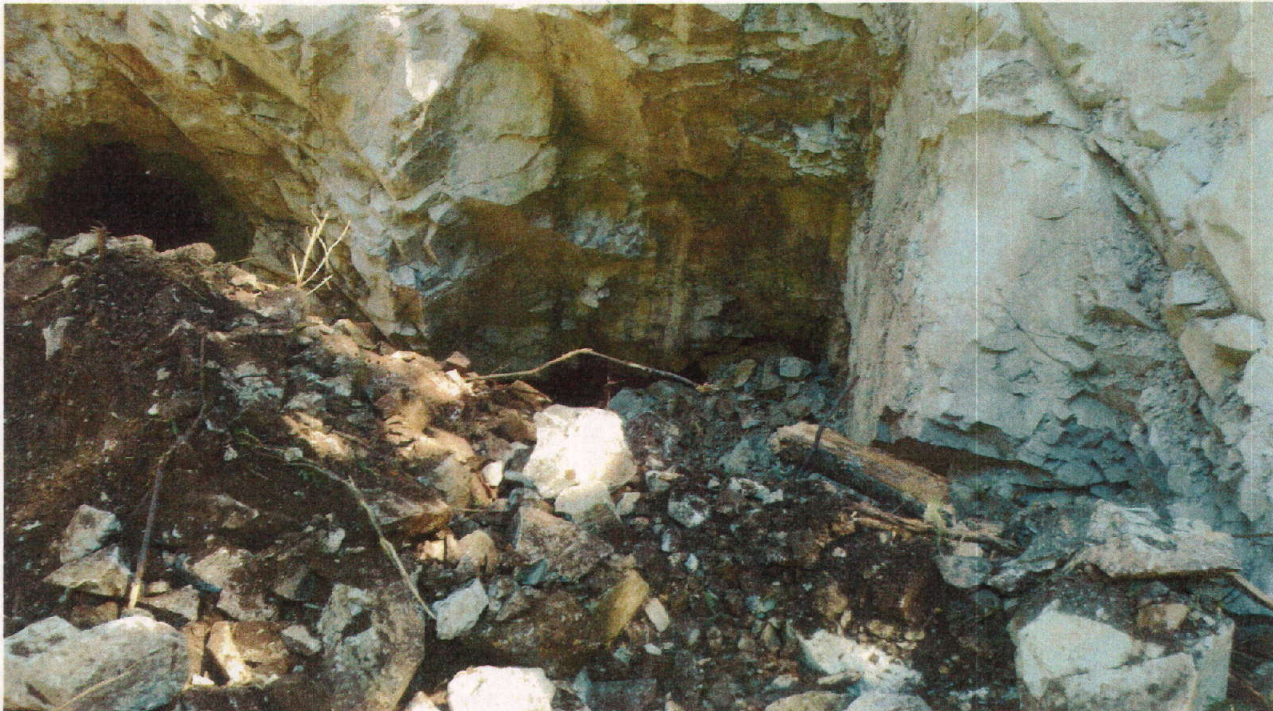
We found what looked like three mine portals. It had been reported to the Division of Water Quality that these portals had been opened as part of the construction and grading activities. We observed two portals that were partially covered and one portal that was open. The open portal had a flow of water coming from it's entrance. It was estimated that the flow from the portal was less than 1 Cubic feet per second (CFS). This water was moving by sheet flow across the newly excavated road in close proximity to Big Cottonwood Creek where it was infiltrating the ground. Given the proximity to the creek it was un-doubtfully flowing into Big Cottonwood Creek. There was no evidence of active mining at the site.

Photo 2. View of old mine portals with debris in front of them. The material in front of these portals looks to be recently deposited there.

1. The mine portals should be sealed as soon as possible. Any discharge of water from these historic mines could be subject to future UPDES permitting.
2. Maintain the erosion control best management practices on the site. While the site is not being required to obtain coverage under the General Permit for Construction Storm Water Activities (UTR300000) at this time, the Utah Division of Water Quality reserves the right

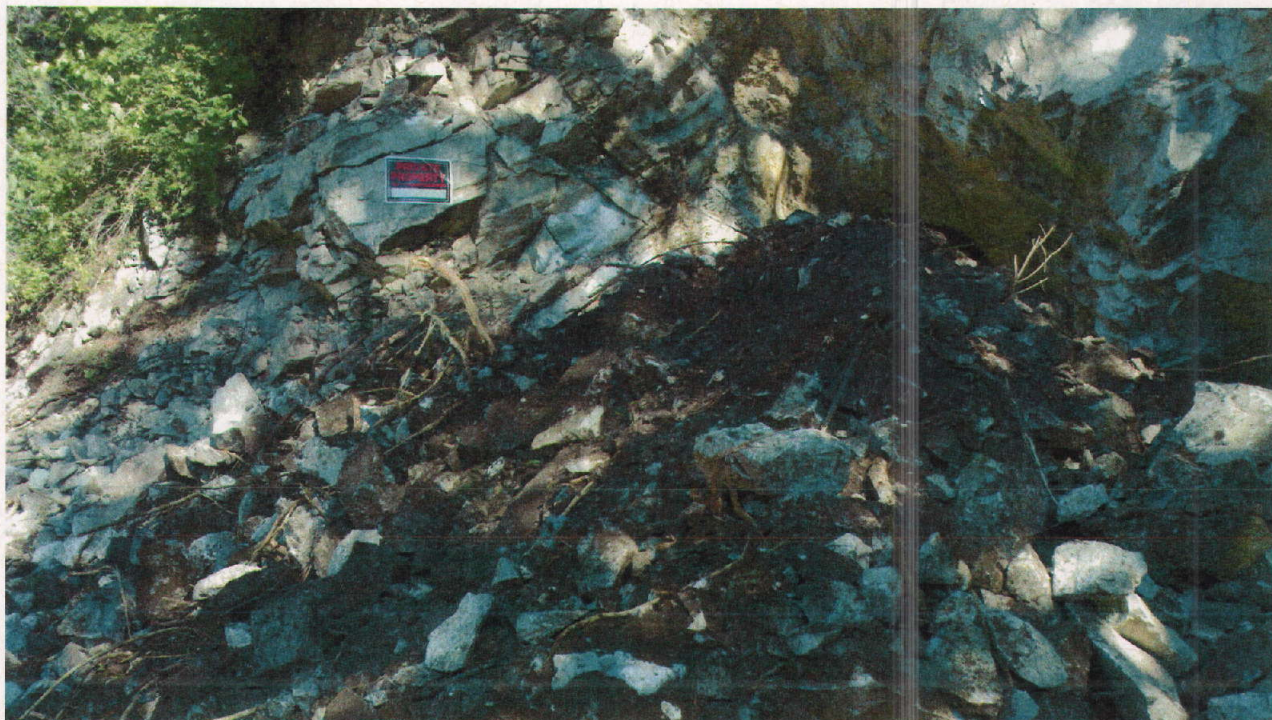
Photo 3. Alternative view of same portal(s) seen in photo 2.

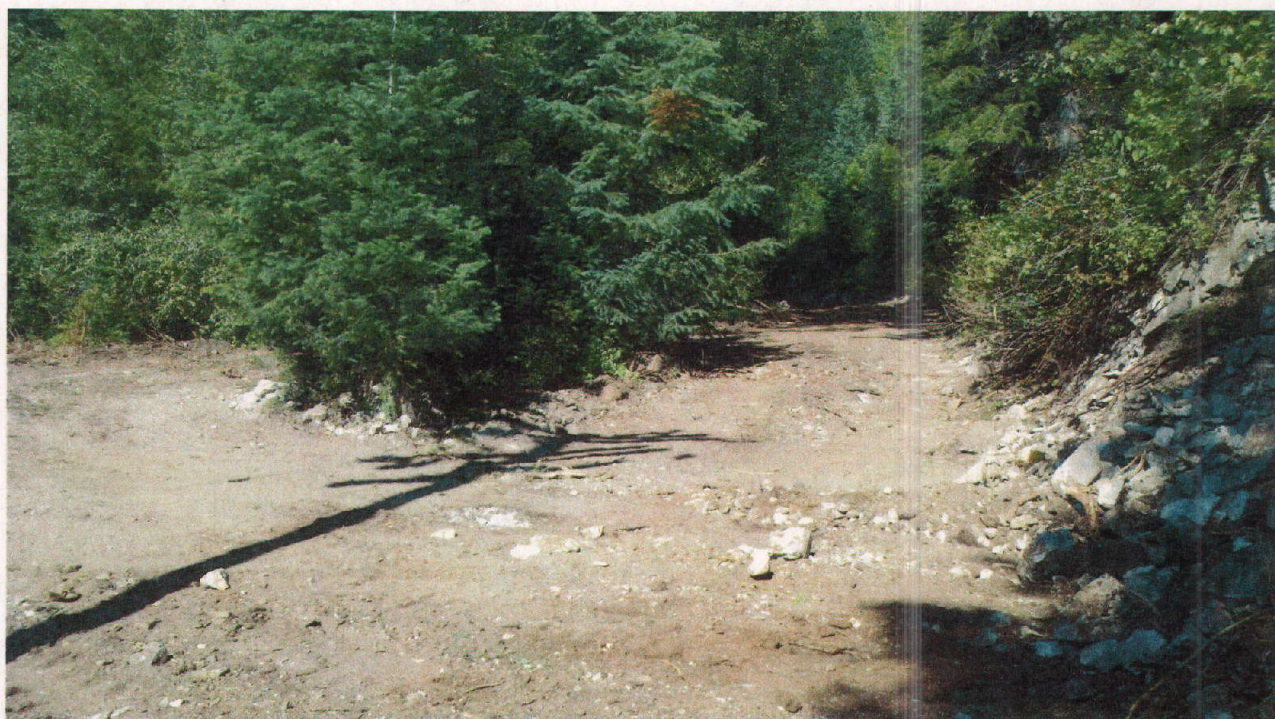
We returned to our vehicle. I took a GPS measurement of the newly disturbed road and found that it was approximately 0.25 miles in length. The estimated width of the road was 15-20 feet. Based on these figures, the estimated area of disturbance was approximately 26,400 sq feet (0.6 acres). This is less than the 1 acre requirement for the General Permit for Construction Storm Water Activities (UTR300000).

Photo 4. View of recently constructed access road to mine portals. View looking east.

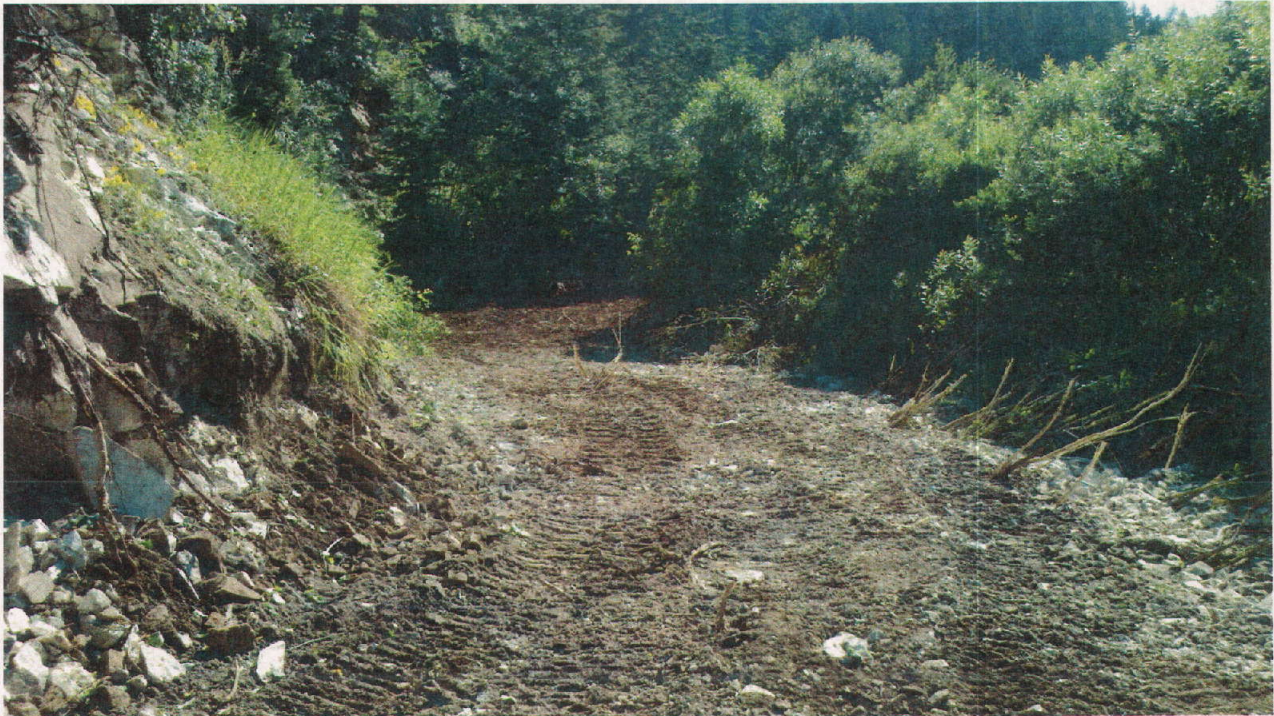
Photo 5. View of recently constructed access road to mine portals. View looking west. Big Cottonwood Creek is to the right of the frame just behind the small willow trees.

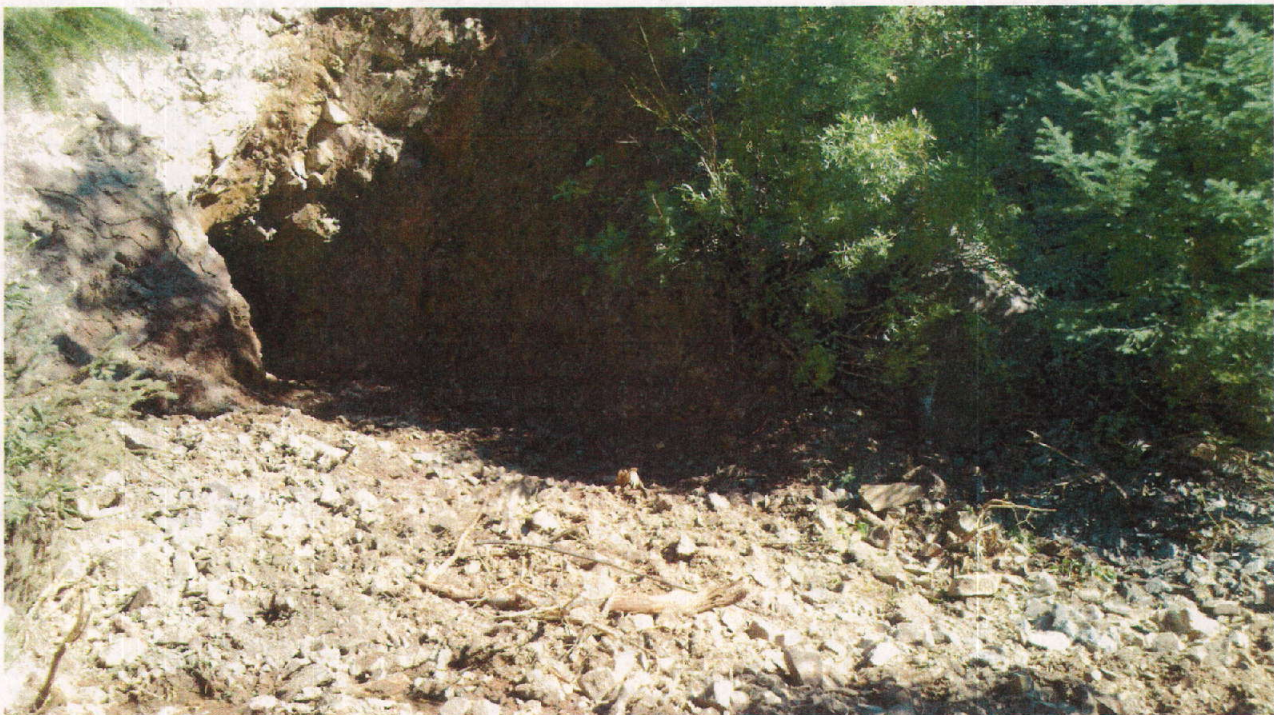
Photo 6. View of entrance to the third mine portal with material removed from in front of the portal.

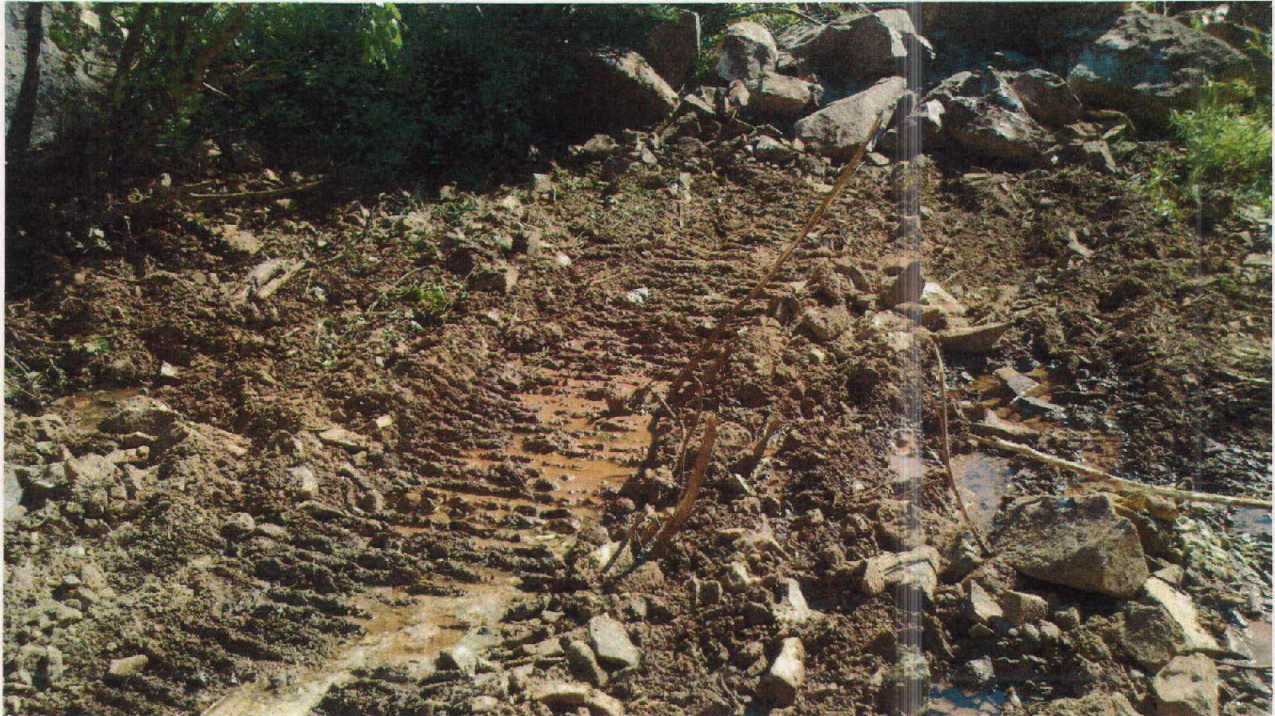
Photo 7. View of water coming from the mine portal infiltrating into the ground.

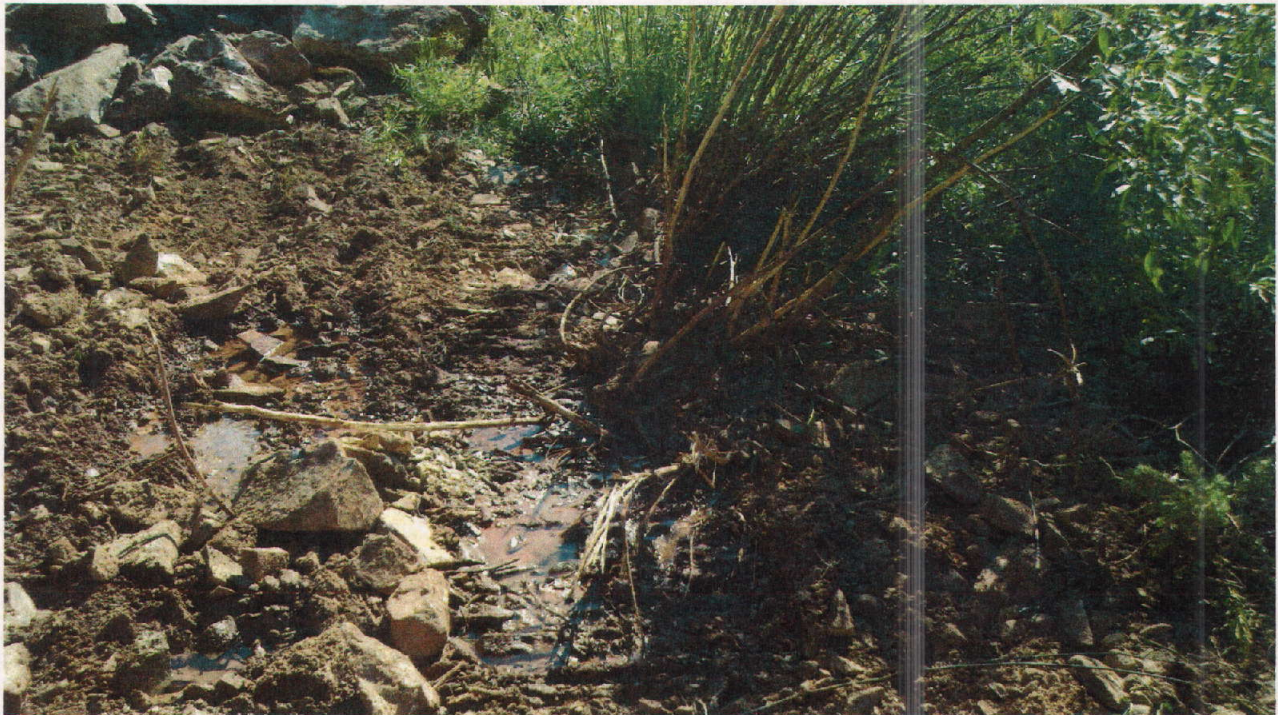
Photo 8. View of water coming from the mine portal infiltrating into the ground. Big Cottonwood Creek is to the right of the frame just behind the small willow trees.

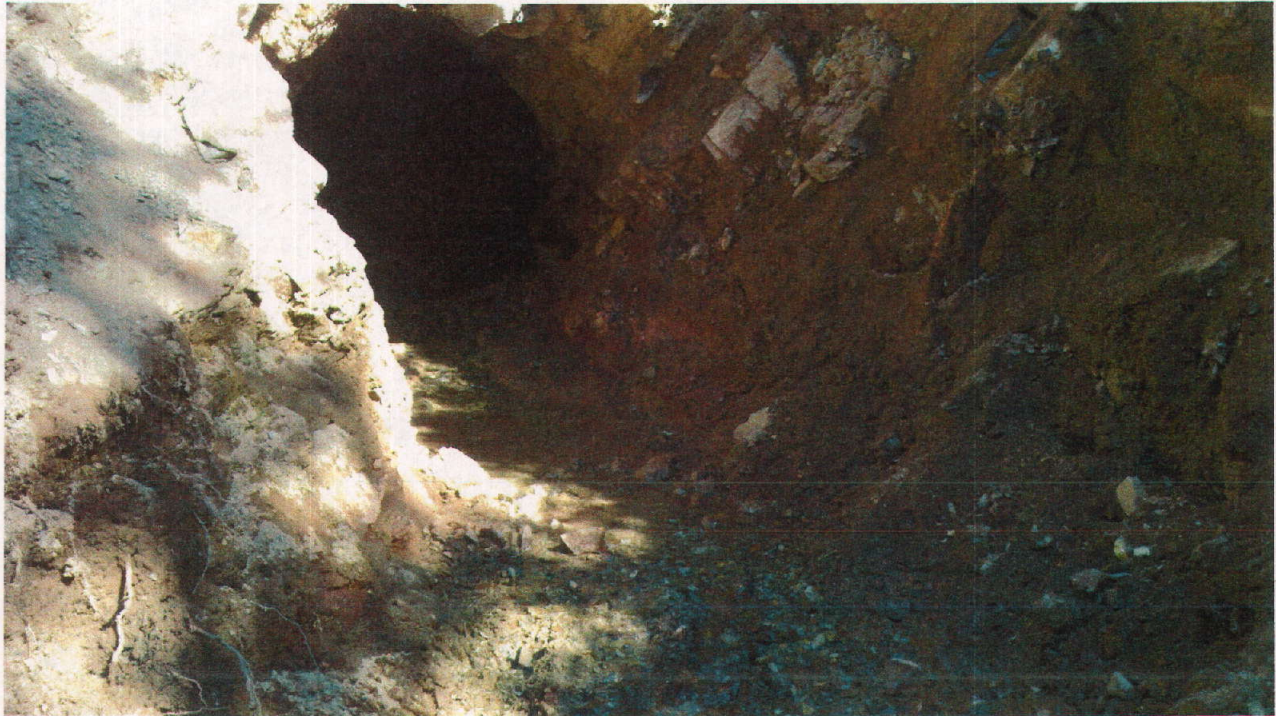
Photo 9. View of water coming from the mine portal infiltrating into the ground.

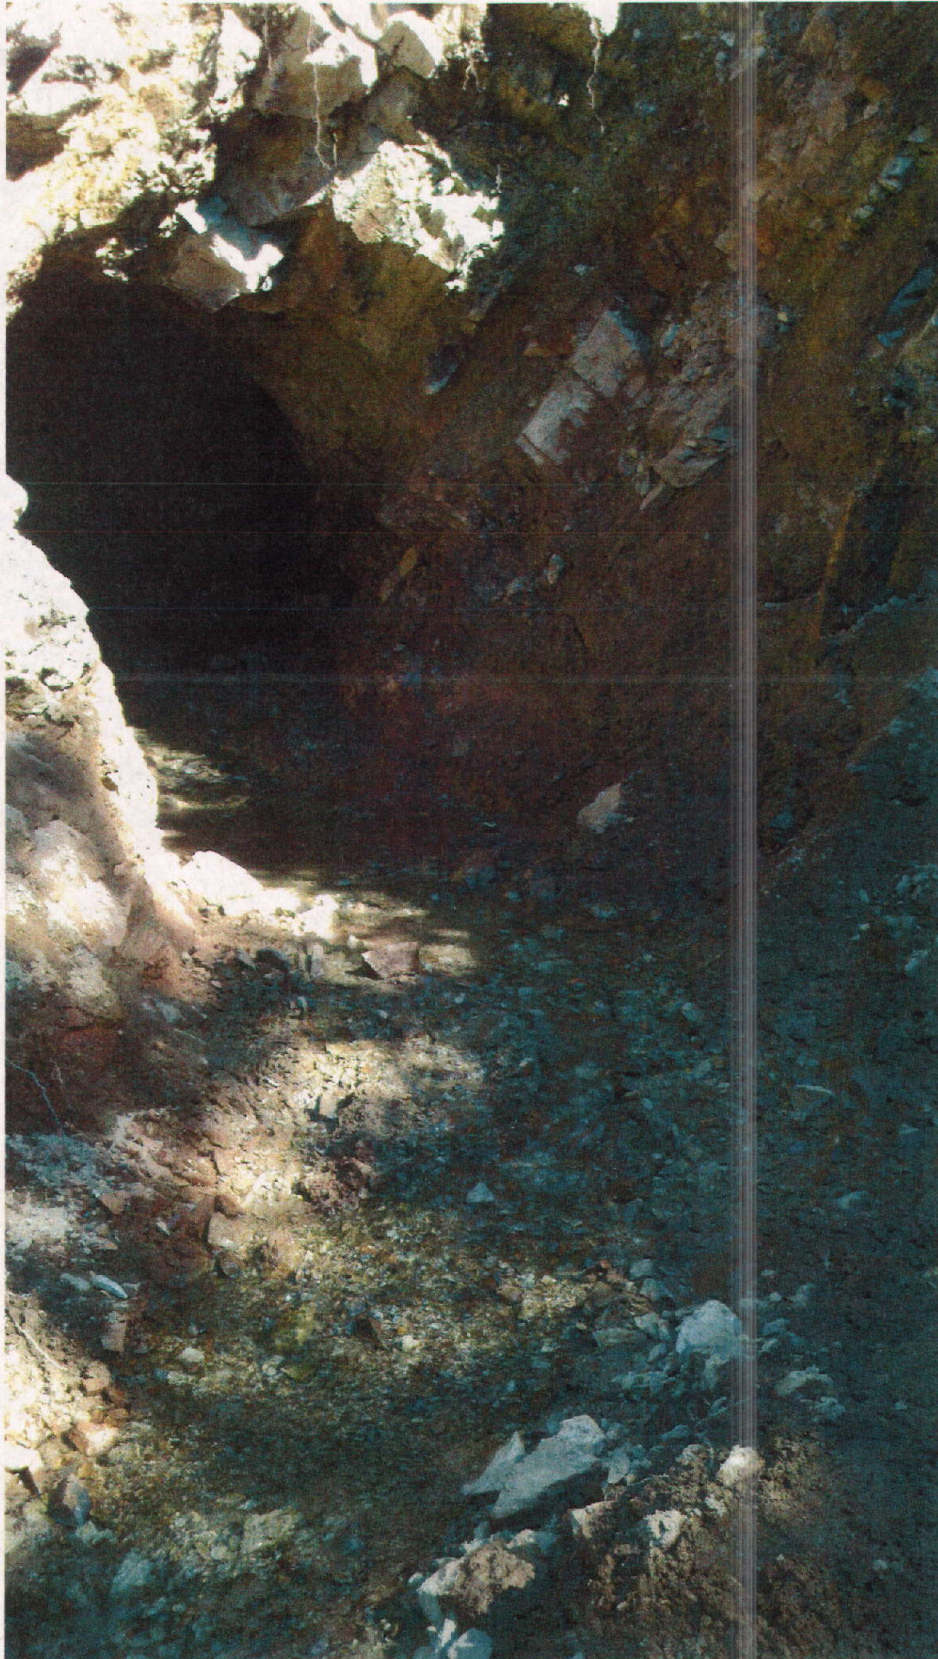
Photo 10. View of water coming from the mine portal infiltrating into the ground.

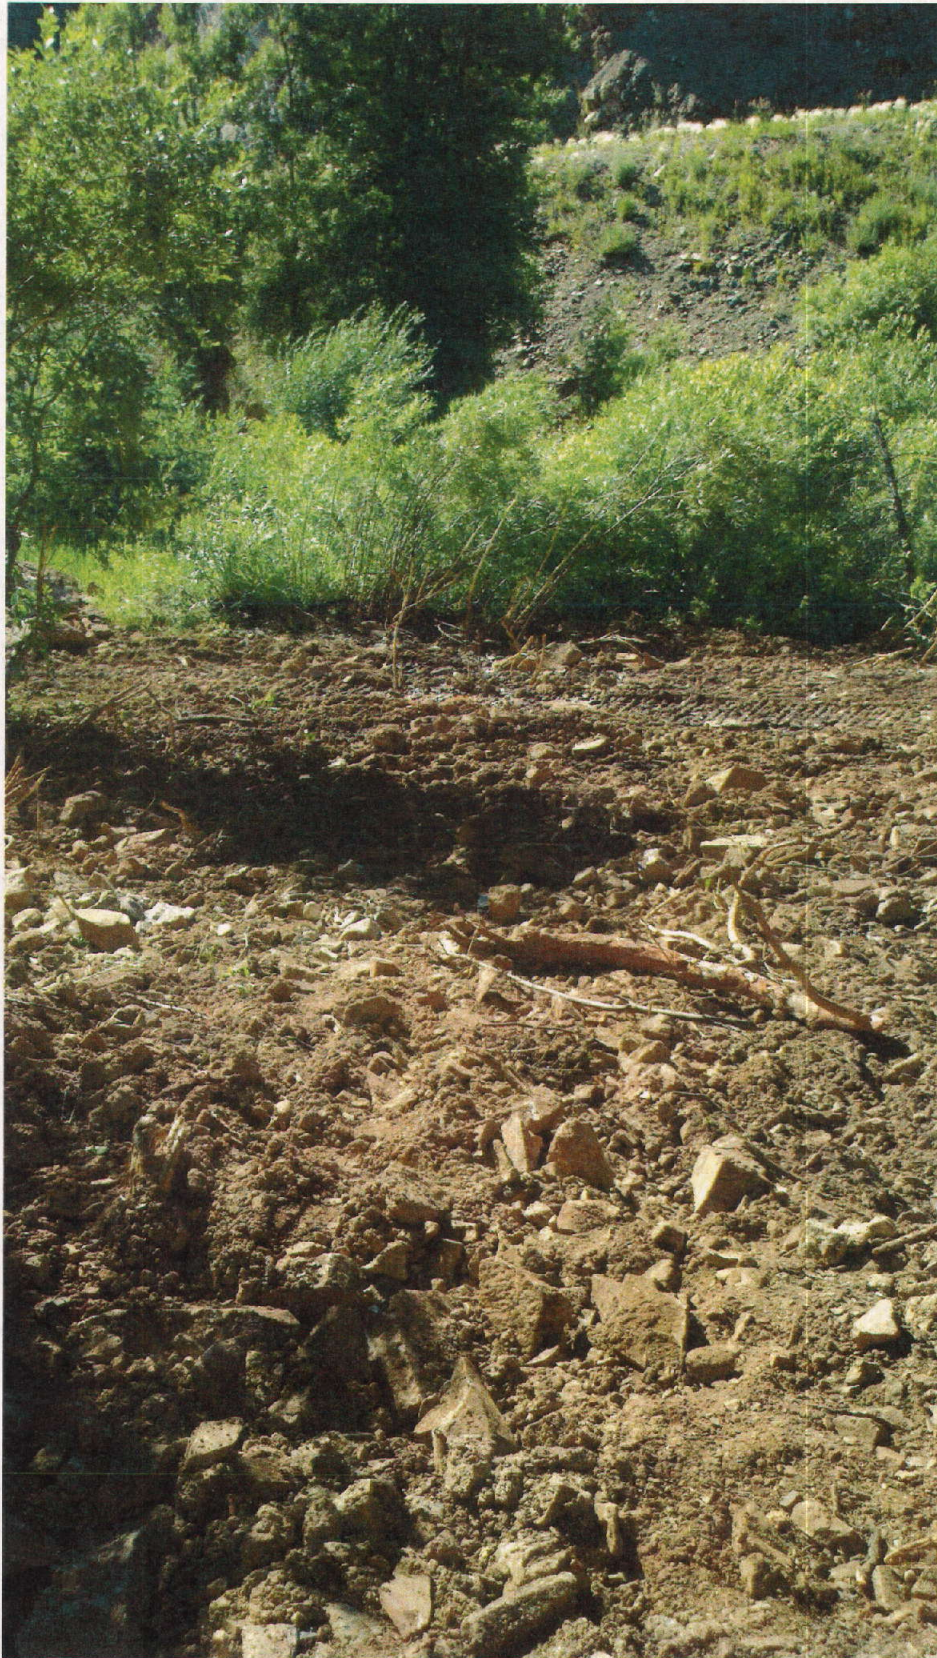
Photo 11. View looking from mine portal towards Big Cottonwood Creek. The creek is just behind the willows. Big Cottonwood Canyon Road is in the upper part of the frame.

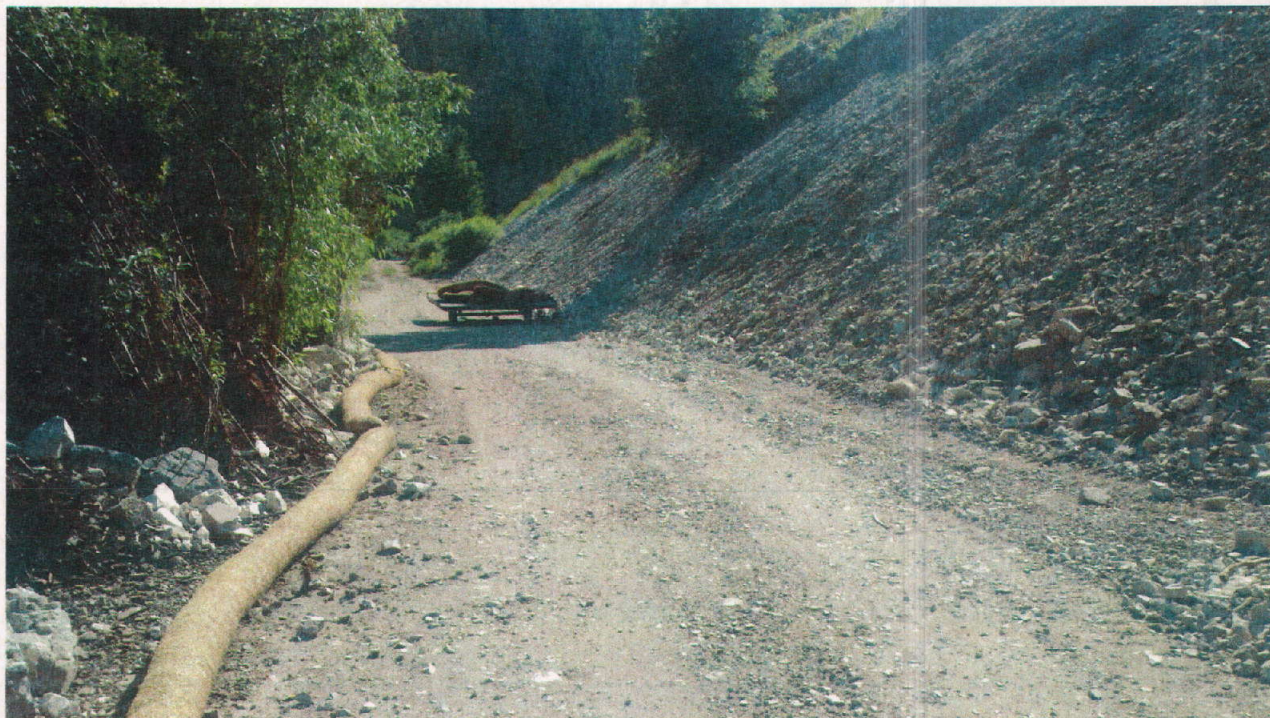
Photo 12. View of road into the site. This was an existing road, but was reworked in places for this project. Big Cottonwood Canyon Road is at the top of the slope on the right of the frame. Straw wattles were installed per instruction of Salt Lake County Planning and Development Services Division.
